NOTE

Bending resistance of repaired column members and shear resistance of opening frames with repaired columns of conventional Japanese wooden houses

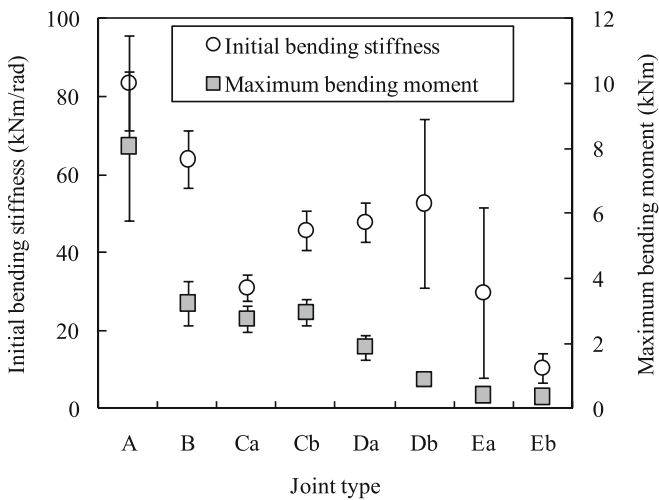
Fig. 5. Initial bending stiffness and maximum bending moment on each joint types. Symbols and bars indicate mean value and standard deviation, respectively

Figure 5 shows the initial bending stiffness and the maximum bending moment of each joint type. The initial bending stiffness differed noticeably depending on joint type and loading direction. Type B showed the highest initial bending stiffness of those repair methods, and its initial bending stiffness was 77% of the control specimen (type A) on average. Type Eb showed the lowest values; its initial bending stiffness was 12% of the control specimen in average. A difference in the initial bending stiffness of joint types Ca and Cb was observed as a result of loading direction, and that of type Ca was 68% of that of type Cb. However, in the other types the effect of loading direction on the initial bending stiffness was not clear because types Db and Ea had a large standard deviation.

The maximum bending moments of the repaired member on each joint type had a small standard deviation and were 4.6% to 40% of the control specimen on average. The maximum bending moment differed with the combination of joint type and loading direction. The maximum bending moment of types Ca and Ea were similar to that of types

Cb and Eb, and the former were 94% and 114%, respectively, of the latter. In contrast, the maximum bending moment of type Da showed a value about two times higher than that of type Db.
