Effects of decay on the shear properties of nailed joints parallel and perpendicular to the grain

Abstract

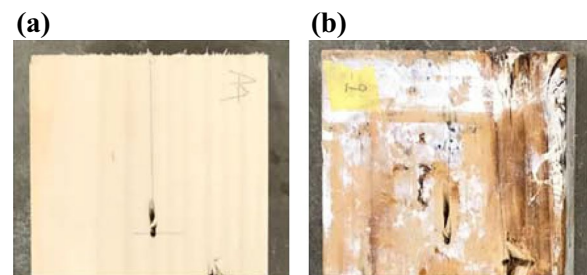
Fig. 7 Control (a) and decayed (b) specimens parallel to the grain after shear tests

The failure modes of the control and decayed specimens parallel to the grain were all nail withdrawals. An apparent difference in failure mode between the control and decayed specimens was not observed in the main members, as shown in Fig. 7. The deformation of the nails can be classified into two modes, as shown in Fig. 8: the mode that has a plastic hinge in the nail (mode I) and the mode with two plastic hinges (mode II). The all-control specimens parallel to the grain exhibited mode II. Six of the twelve decayed specimens exhibited mode I and six

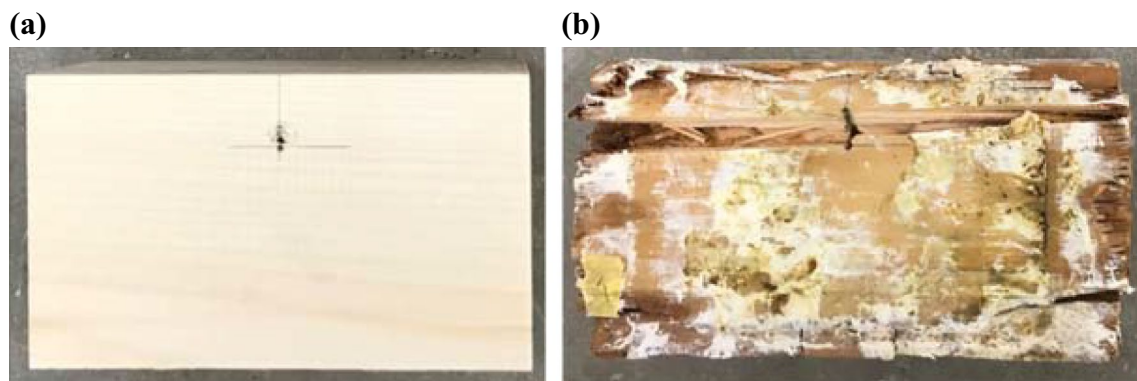
Fig. 9 Control specimen with nail withdrawal (a) and decayed specimen with main member splitting (b) after the shear tests perpendicular to the grain

The failure mode of the nailed joints perpendicular to the grain can be classified into two types: nail withdrawal and main member splitting. No specimen exhibited nail-head pull-through. The failure mode of all the control specimens was nail withdrawal. Five decayed specimens failed by nail withdrawal, and seven exhibited main member splitting, as shown in Fig. 9. It is most likely that the degradation of wood by decay changed the failure mode of nailed joints perpendicular to the grain. Deformation of the nail was by mode II for all the control specimens and 10 decayed specimens. The two decayed specimens deformed by mode I. In the nailed joints perpendicular to the grain, embedding and tensile stress perpendicular to the grain are generated around the

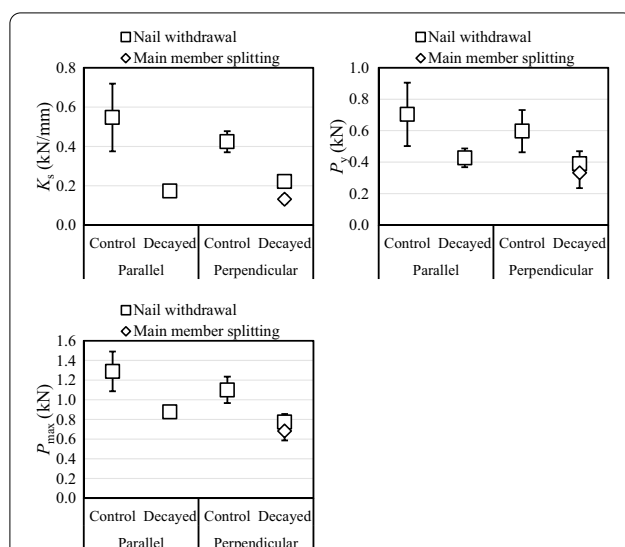
Fig. 11 Shear properties of nailed joints parallel and perpendicular to the grain. K_s , initial stiffness; P_y , yield shear resistance; P_{max} , maximum shear resistance

The shear properties of the nailed joints were evaluated based on the initial stiffness (K_s), yield resistance (P_y), and maximum resistance (P_{max}). A perfect elastoplastic idealization scheme using 10, 40, and 90% of P_{max} [11, 20] was applied to the load–slip curves to obtain K_s and P_y . Figure 11 shows the values of K_s , P_y , and P_{max} of the nailed joints parallel and perpendicular to the grain. The values of K_s , P_y , and P_{max} were all significantly different between the control and decayed specimens in each loading direction at the 5% level. The K_s , P_y , and P_{max} values of the decayed specimen parallel to the grain were 68.4%, 39.2%, and 31.9% smaller, respectively, than those of the control specimen. For the nailed joints perpendicular to the grain, K_s , P_y , and P_{max} values of the decayed specimen were 60.2%, 40.3%, and 34.4% smaller, respectively,

than those of the control specimen. There was no clear difference in the shear properties degradation of nailed joints depending on the loading directions. The value of K_s exhibited the largest decrease, followed by those of P_y and P_{max} for both the nailed joints parallel and perpendicular to the grain. On the other hand, some preceding studies on the nailed [2] and screwed [9, 11] joints parallel to the grain have reported that degradation of the initial stiffness was not present regardless of decay. In those studies, decay treatment was conducted on the surface of the specimens similarly as in this study; however, the effective length of the fasteners was 1.3–1.6 times that in this study. Presumably the long effective length of the fasteners maintained the initial stiffness in those studies, and the result in this study implied that degradation of the initial stiffness would be present if shorter fasteners were used. Compared to the failure mode of decayed specimens perpendicular to the grain, the decayed specimens that failed by the main member splitting showed lower K_s values than those that failed by nail withdrawal, and the former had almost the same P_y and P_{max} as the latter. The failure mode of the nailed joints perpendicular to the grain had little effect on the initial stiffness.
