# Experimental study of compressive properties parallel to grain of glulam

## Abstract

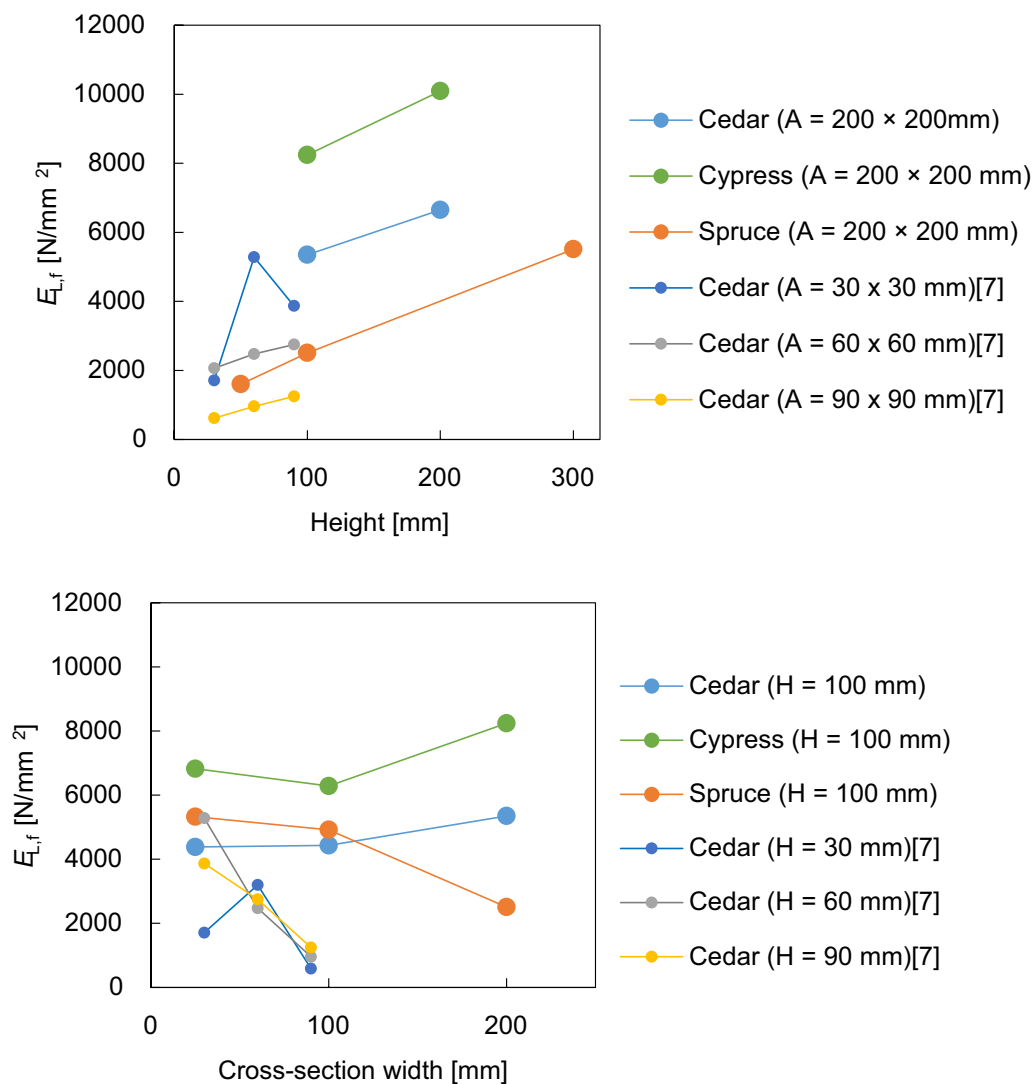
**Fig. 8** Influence of heights and widths of cross-sectional area on values of  $E_{L,f}$

Figure 8 presents the influence of the heights and the widths of the loaded area on the values of  $E_{L,F}$ . The test results of solid timber of cedar [7] are also shown in Fig. 8. These values indicate mean values of the

specimens with a cross-sectional area of  $200 \times 200$  mm and  $30 \times 30$ – $90 \times 90$  mm [7] for the influence of the heights and with a height of 100 mm and  $30$ – $90$  mm [7] for the influence of the widths of the loaded area. The  $E$

$E_{L,f}$  had an increasing trend as the height increased. This can be explained by that the lengths of the damage zone do not change when the full height of the specimens increases. The  $E_{L,f}$  had an increasing trend as the width of the loaded area decreased in the spruce specimens and solid timber. This can be explained by the increasing lengths of the damage zone with the increase of the widths of the loaded area. However, the  $E_{L,f}$  did not have an increasing trend in the cedar and cypress specimens. To clarify the mechanism of the damage zone, the damage zones were analyzed in the following.

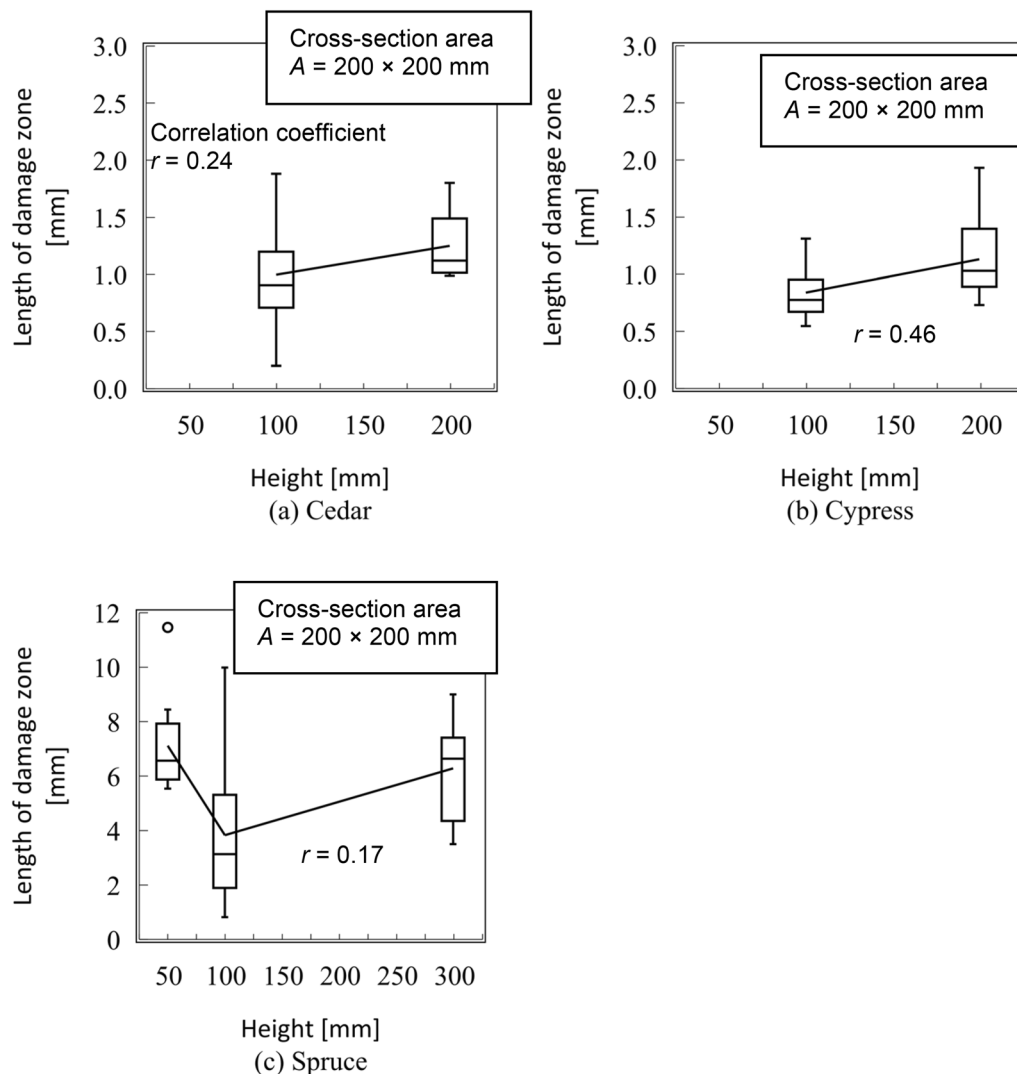
**Fig. 12** Length of damage zone of specimens of varying heights

the processing of the spruce specimens was rougher than that of the cedar and cypress specimens. The cedar and cypress specimens were processed on the same machine. The surface roughness of the contacted area is likely to increase as the cross-sectional area of the specimens increases. In other words, the length of the damage zone may depend on the accuracy of the processing machine. The details of the surface roughness on the contact surface were investigated in the following. On the other hand, lower or negligible correlations between the length of the damage zone and the height of the specimen were indicated with correlation coefficients of +0.24 for the cedar specimens, +0.46 for the cypress specimens and +0.17 for the spruce specimens in Fig. 12. The length of the damage zone did not change when the height of the specimen changed.

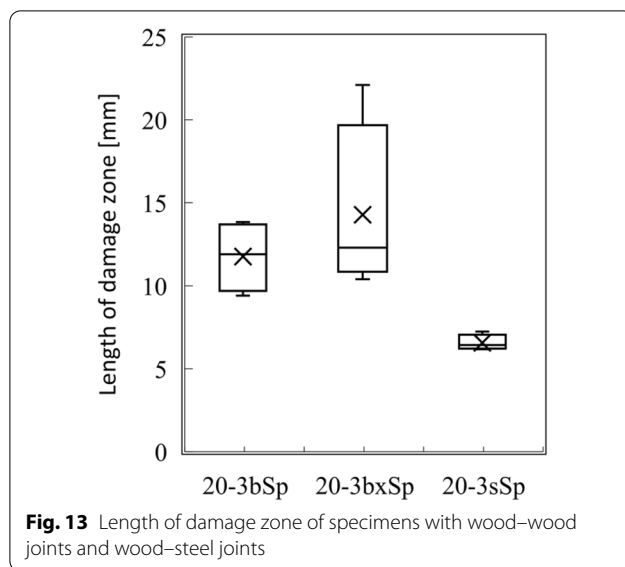
Figure 13 shows the length of the damage zone near wood–wood joints and wood–steel joints. It was considered that the lengths of the damage zone of wood–wood joints are larger than that of wood–steel joints.
